**MARYLAND HISTORICAL TRUST  
DETERMINATION OF ELIGIBILITY FORM**

Property Name: Washington Grove Humpback Bridge Inventory Number: M: 21-220  
Address: East Deer Park Drive over CSX Transportation, Inc. Railroad tracks at Railroad Street Historic district: ☐ yes ☒ no  
City: Washington Grove Zip Code: 20880 County: Montgomery  
USGS Quadrangle(s): Gaithersburg  
Property Owner: CSX Transportation, Inc. Tax Account ID Number: N/A  
Tax Map Parcel Number(s): N/A Tax Map Number: N/A  
Project: National Gateway Initiative Clearance Project Agency: FHWA/SHA  
Agency Prepared By: A.D. Marble & Company  
Preparer's Name: Emma Young Date Prepared: 10/6/2009  
Documentation is presented in: Montgomery County Planning Department, Historic Preservation Section, Silver Spring, Maryland.  
Preparer's Eligibility Recommendation: ☒ Eligibility recommended ☐ Eligibility not recommended  
Criteria: ☒ A ☐ B ☒ C ☐ D Considerations: ☐ A ☐ B ☐ C ☐ D ☐ E ☐ F ☐ G  
*Complete if the property is a contributing or non-contributing resource to a NR district/property:*

Washington Grove Humpback Bridge

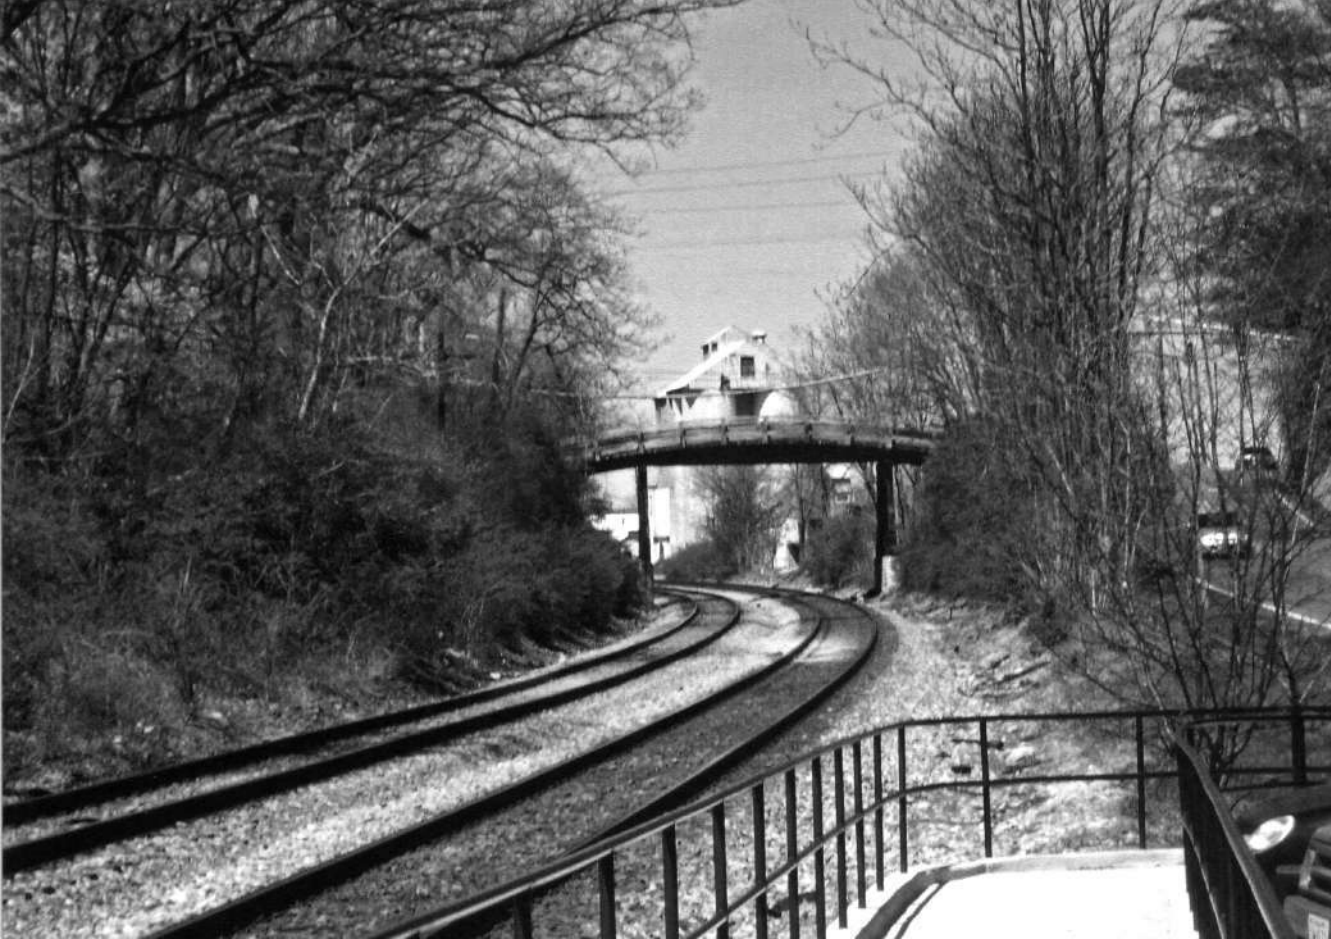
PHOTO 1 OF 6

WASHINGTON GROVE HUMPBACK BRIDGE. VIEW TO NORTH.

NOTE RAILROAD STREET TO RIGHT.

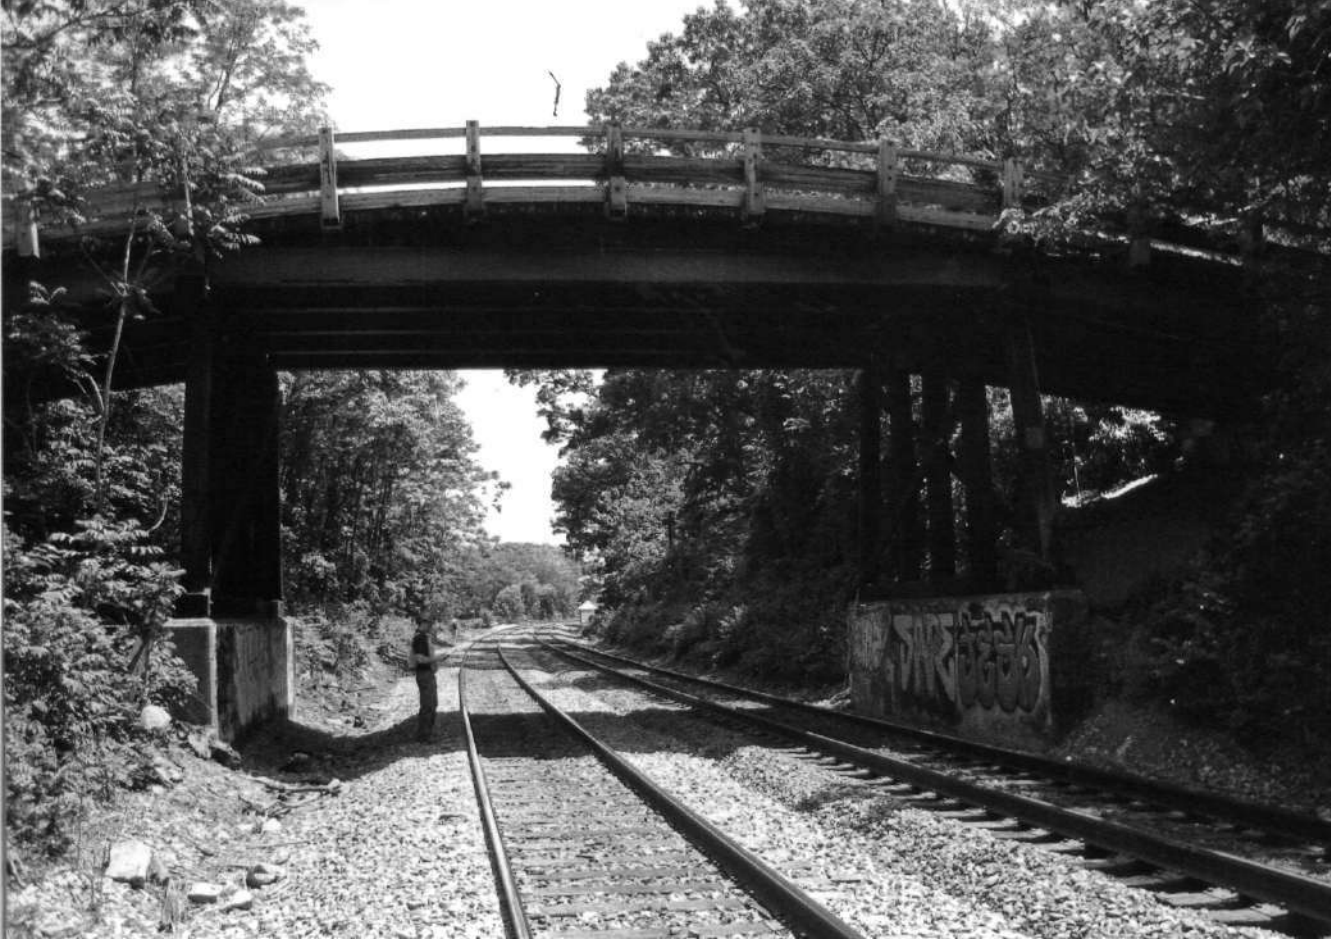
PHOTO 2 of 6

WASHINGTON GROVE HUMPBACK BRIDGE, VIEW TO SOUTH.

NOTE TIMBER RAILINGS AND PIERS.

The substructure of the bridge is comprised of timber bents set into concrete footings, concrete abutments, wingwalls, and slope between the abutment and bent footings. The timber bents were added in spring 2009 as part of an in-kind replacement that replicated the previous configuration. Each timber bent is comprised of five 12-inch-by-12-inch vertical posts approximately 14-feet high resting on timber bases bolted to a concrete footing. Diagonal timbers stretch from the cap of the bent to the base, and the outer two vertical posts lean inward, giving the bent a trapezoidal shape. All stringers are bolted into the cap of the timber bents; the outer stringers are bolted into the concrete abutments through a wood sill.

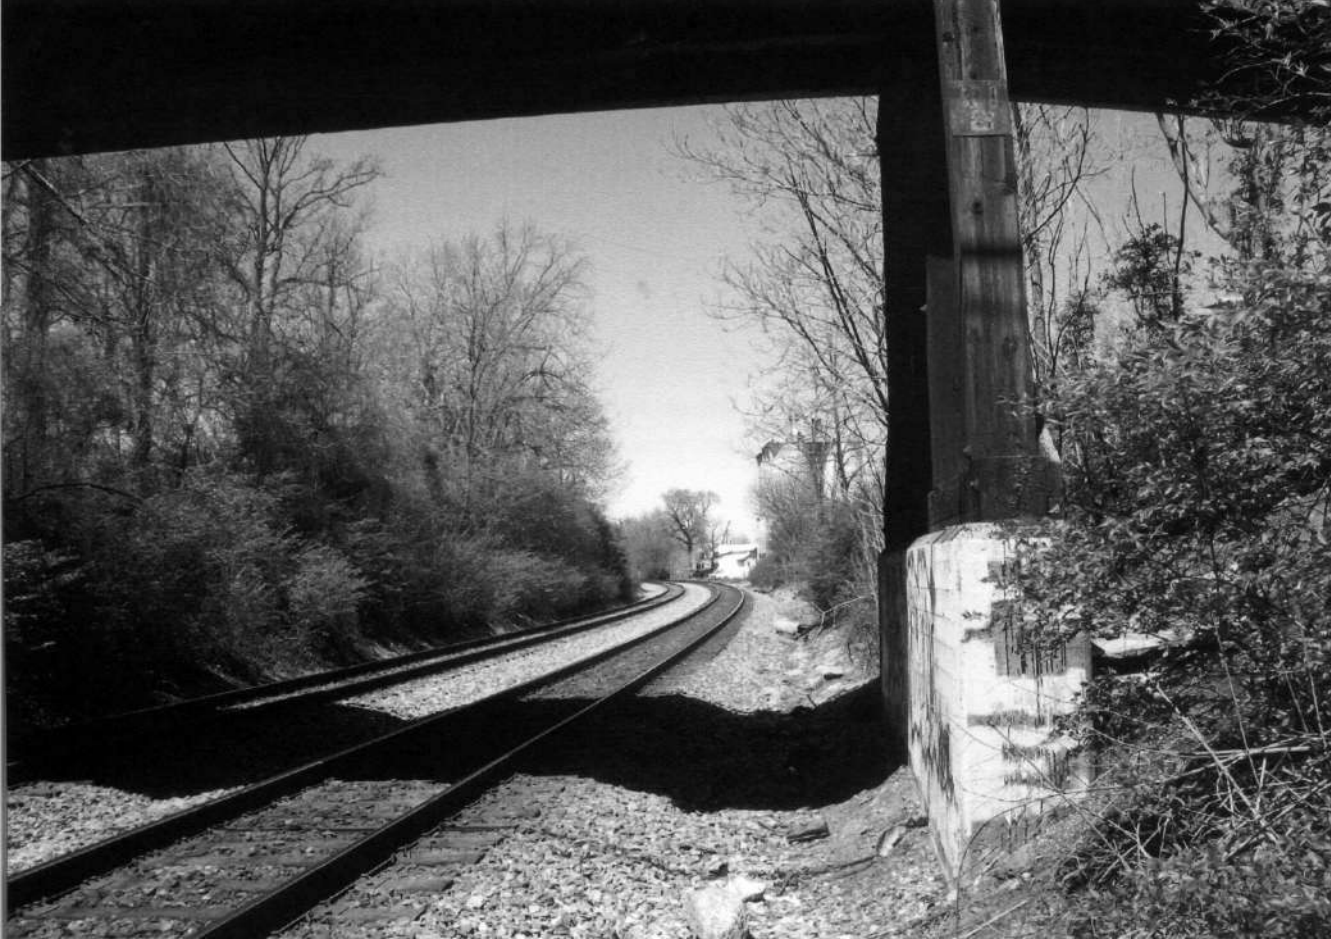
PHOTO 4 OF 6

WASHINGTON GROVE HUMPBACK BRIDGE, VIEW TO NORTH.  
DETAIL OF EAST TIMBER PIER SET INTO CONCRETE  
ABUTMENT

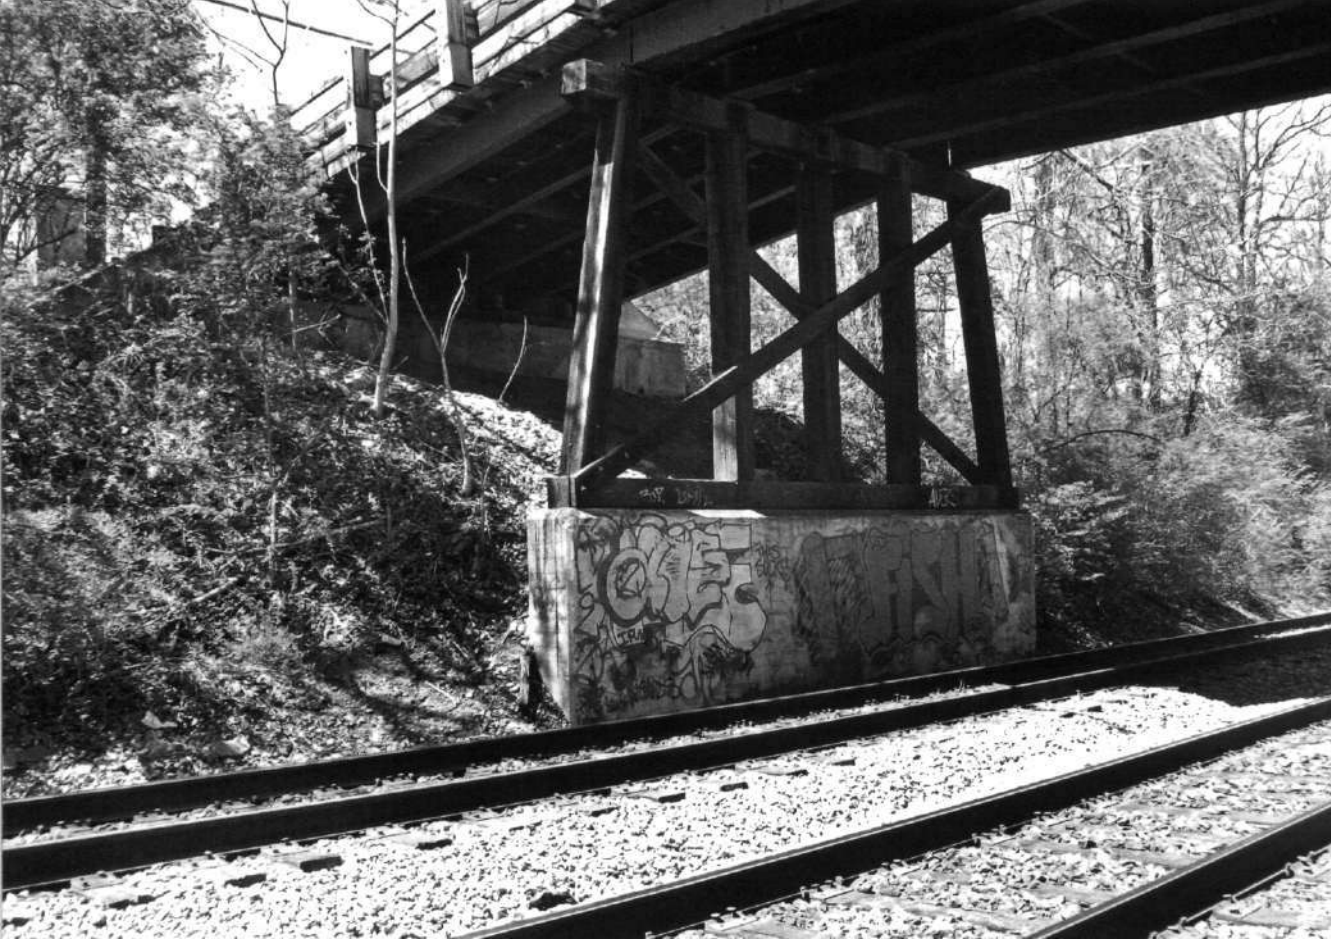
PHOTO 5 OF 6

WASHINGTON GROVE HUMPSACK BRIDGE, VIEW TO  
NORTHWEST. DETAIL OF WEST TIMBER PIER SET  
INTO CONCRETE ABUTMENT

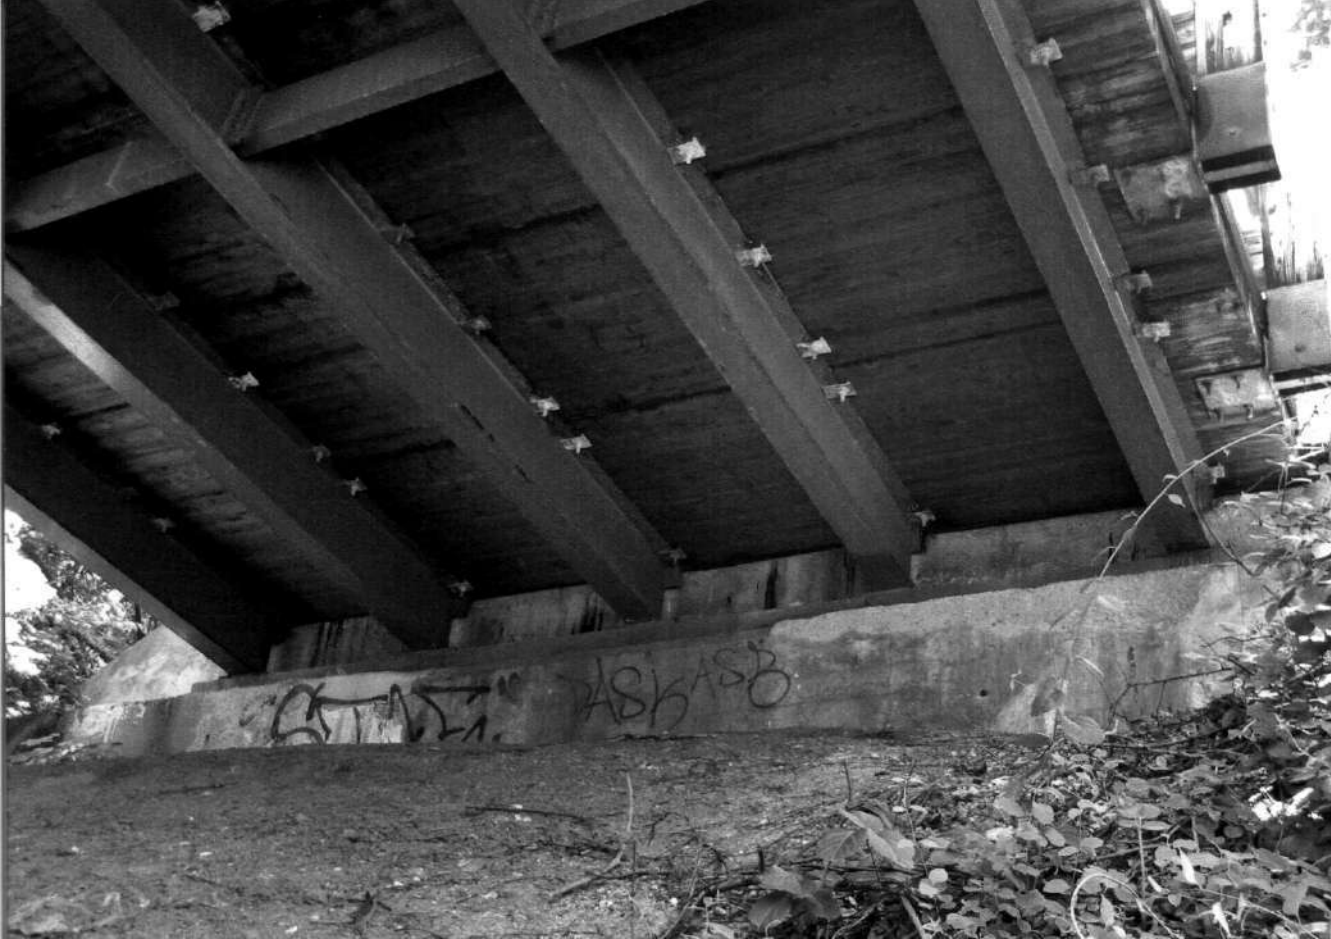
PHOTO 6 of 6

WASHINGTON GROVE HUMPBACK BRIDGE, VIEW TO SOUTHWEST.

DETAIL OF TIMBER DECK

The Washington Grove Humpback Bridge consists of an 85-foot long, 22-foot wide, three-span steel beam structure, with a timber deck and bituminous concrete surface. Each of the three spans is comprised of five sets of steel I-beam stringers, with both ends of the center span stringers resting on two timber bents on either side of the railroad tracks. The two outer spans extend from concrete abutments at the approach level to rest on timber bents. A curving shim rests on each of the five center-span stringers, giving the bridge its humpback profile. A double-strand timber railing and W-beam metal guardrail frame the superstructure. Galvanized shoes bolted to blocks on the outer stringer anchor the wood posts of the railing.
